TECHNICAL REPORT N-70-10

**SURVEY OF GULF COAST
STRUCTURAL DAMAGE RESULTING FROM
HURRICANE CAMILLE, AUGUST 1969**

By U. S. Army Engineer Waterways Experiment Station, Vicksburg, Mississippi

April 1970

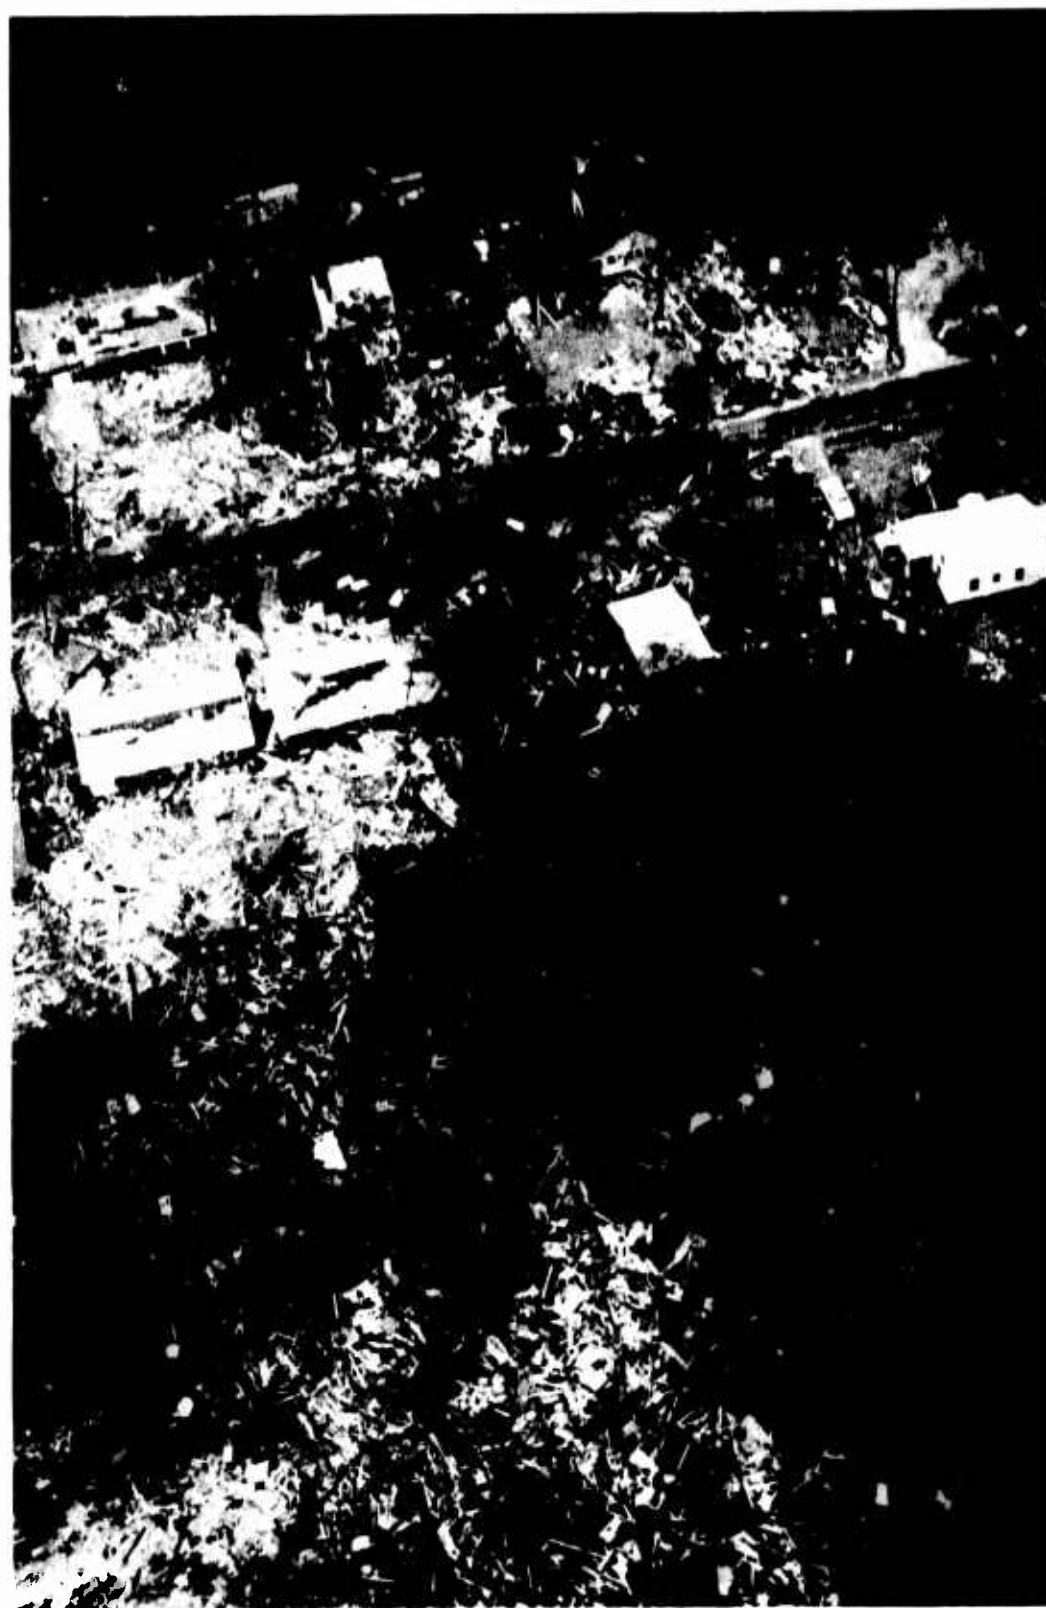
The extent of debris deposited inland marked the limit of greatest tidal action. The debris line is clearly seen in Figure 2.17.

Figure 2.17 Residences and debris line in west Gulfport, Mississippi.

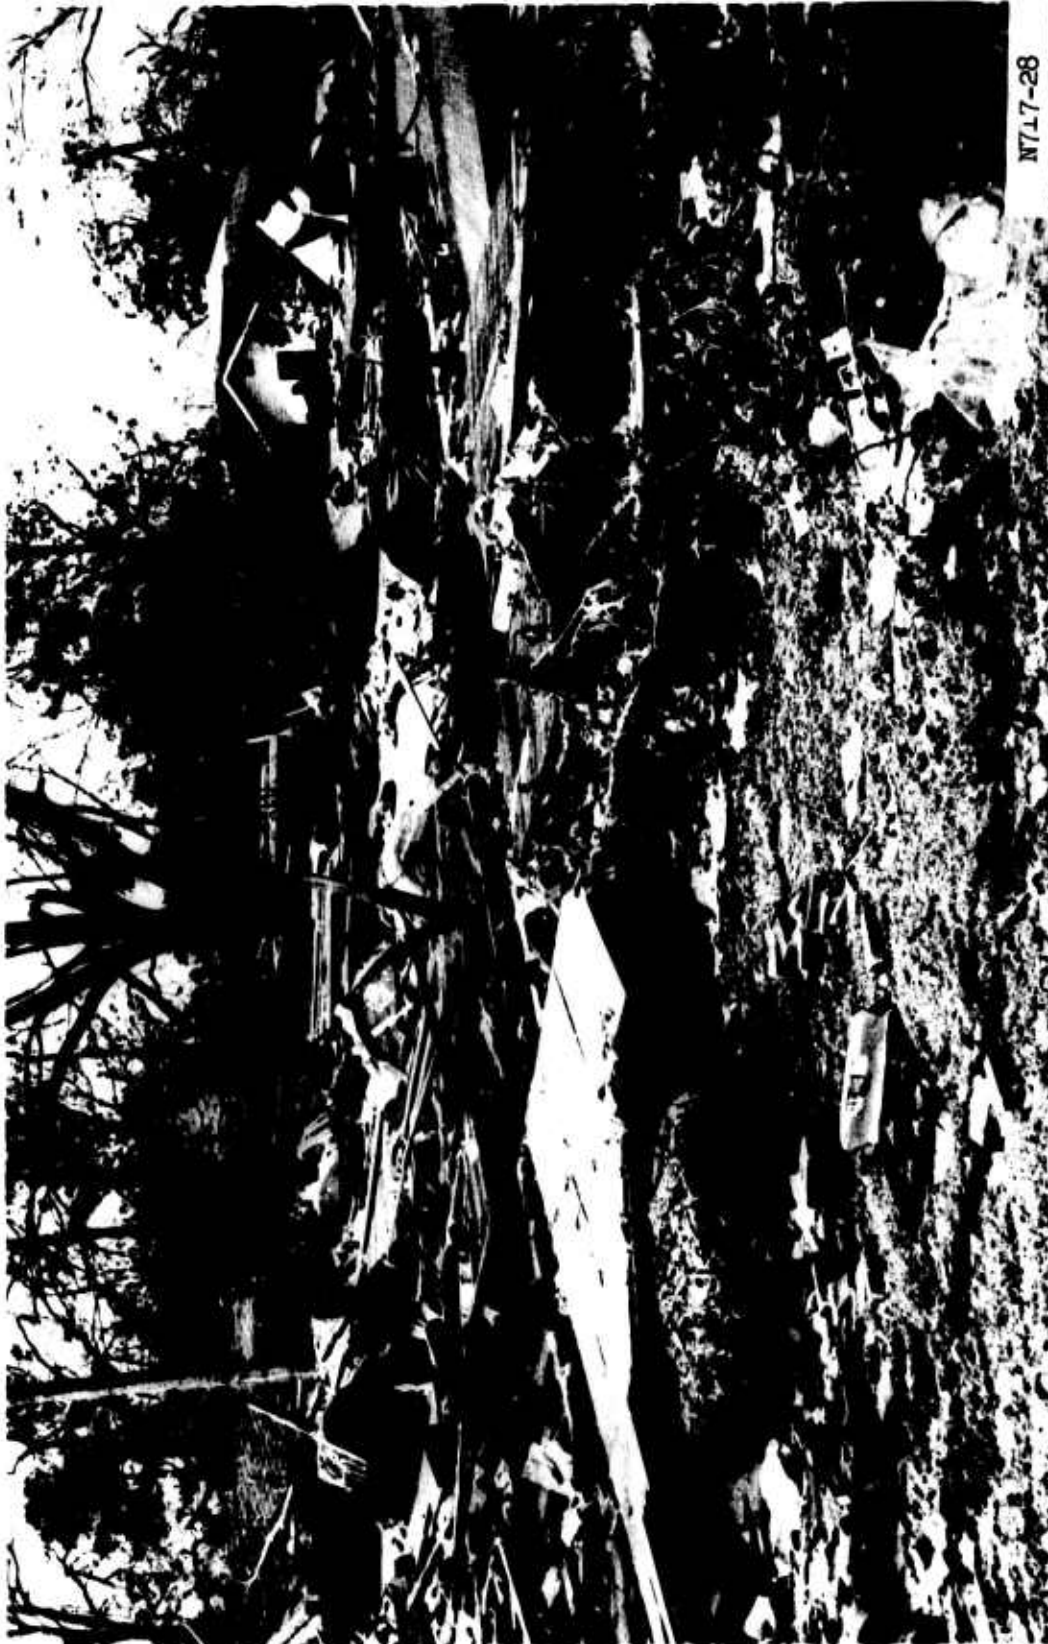
Figure 2.29 Debris from residences and Port facilities, west Gulfport, Mississippi.

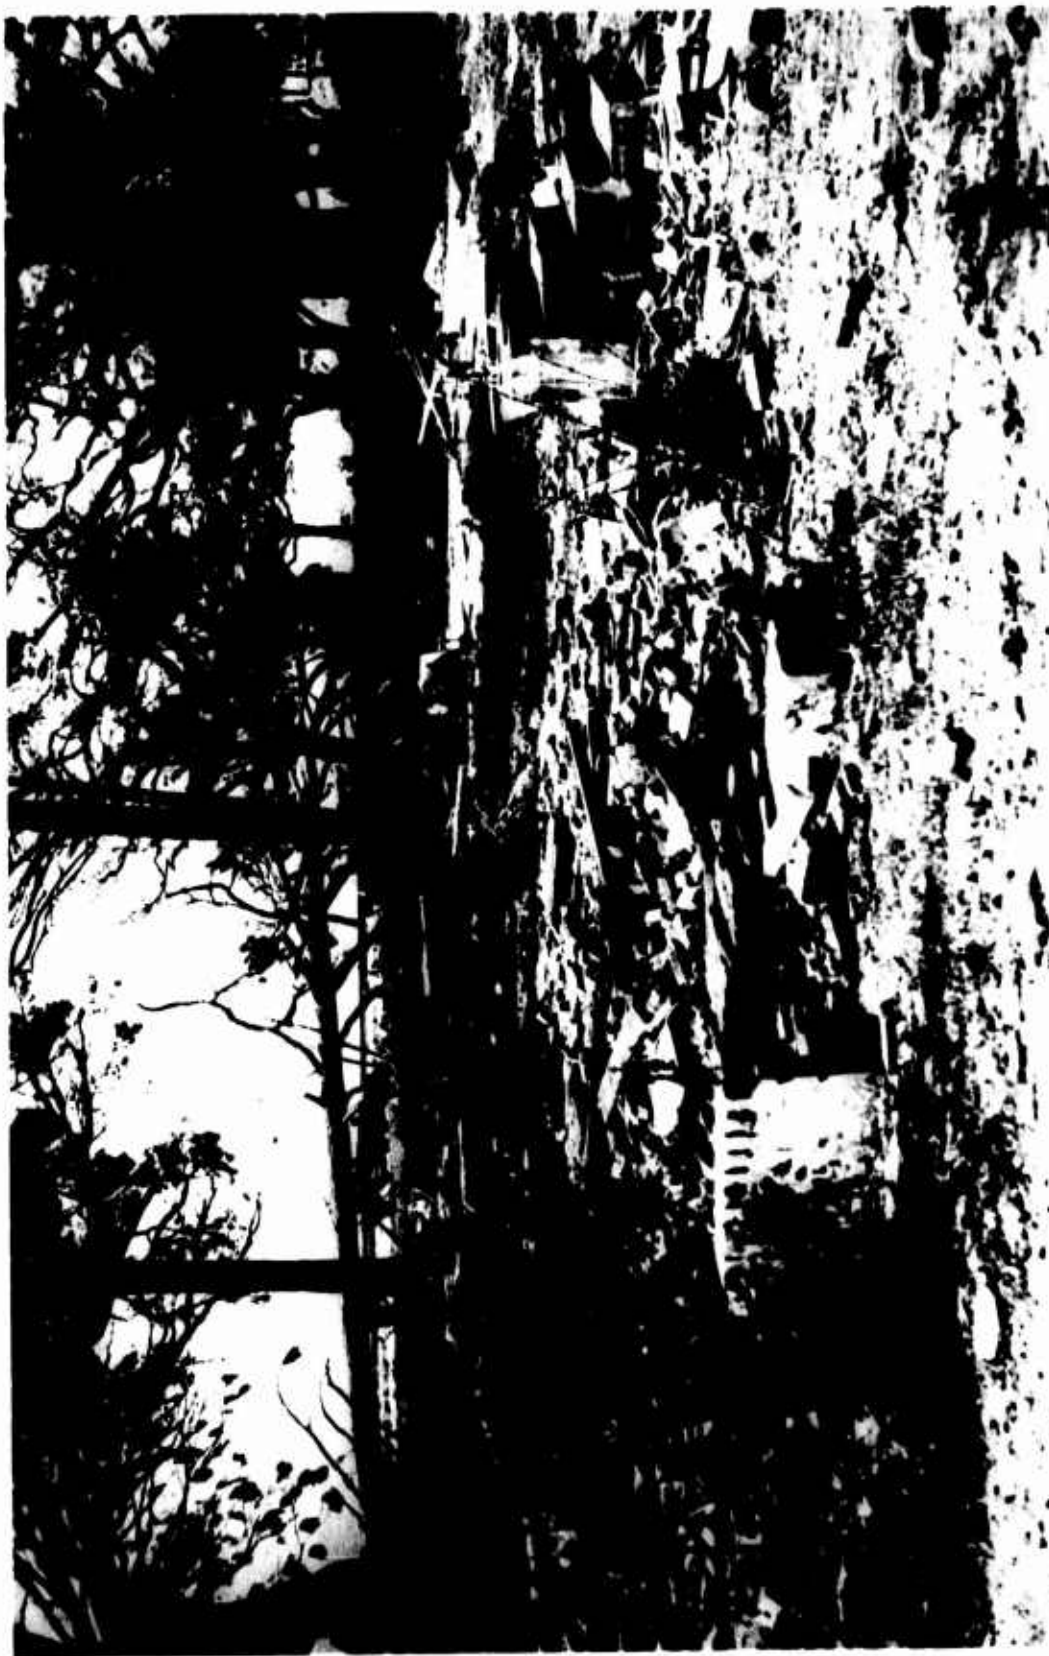
Figure 2.35 Residence near Long Beach, Mississippi.

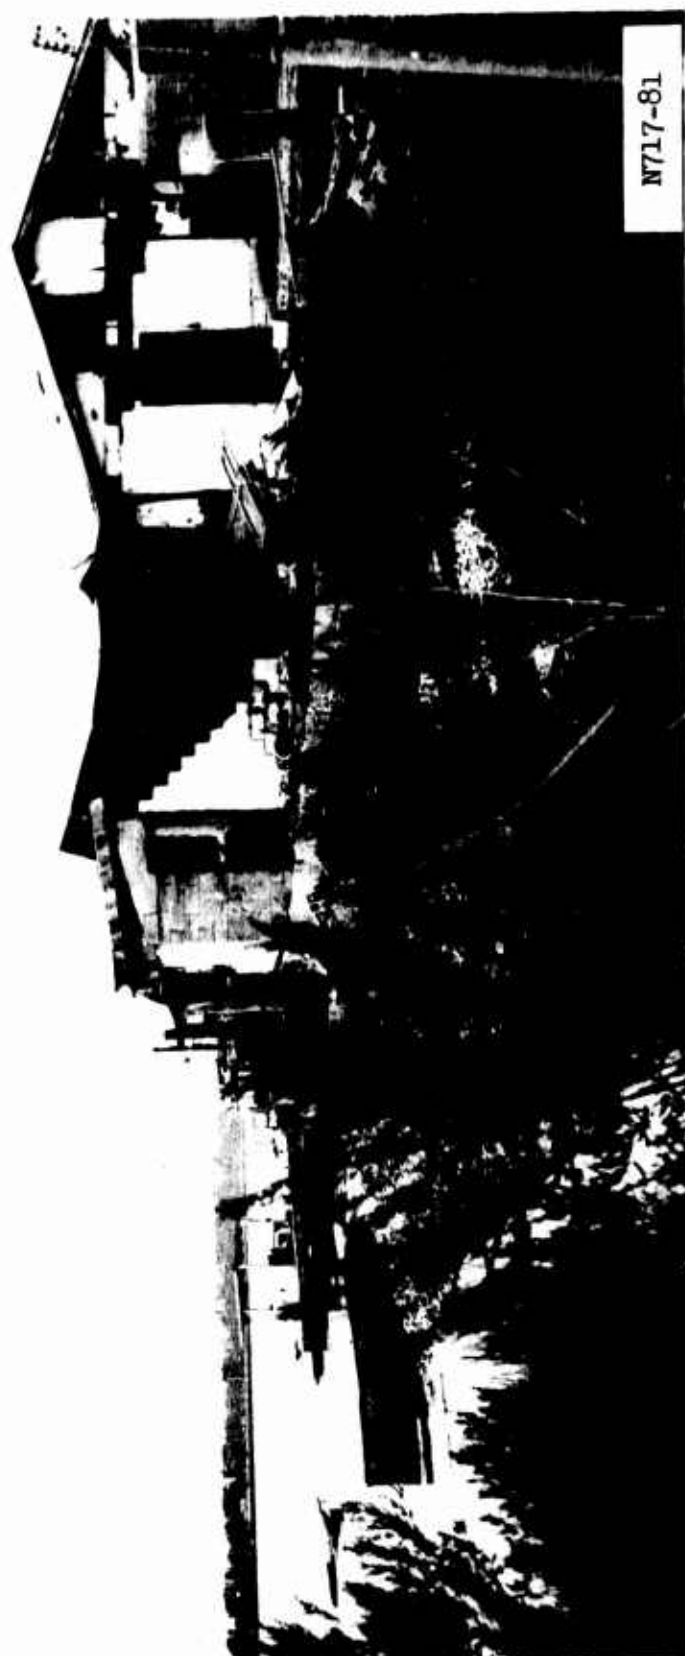
Figure 2.37 Commercial building, Back Bay of Biloxi, Mississippi.

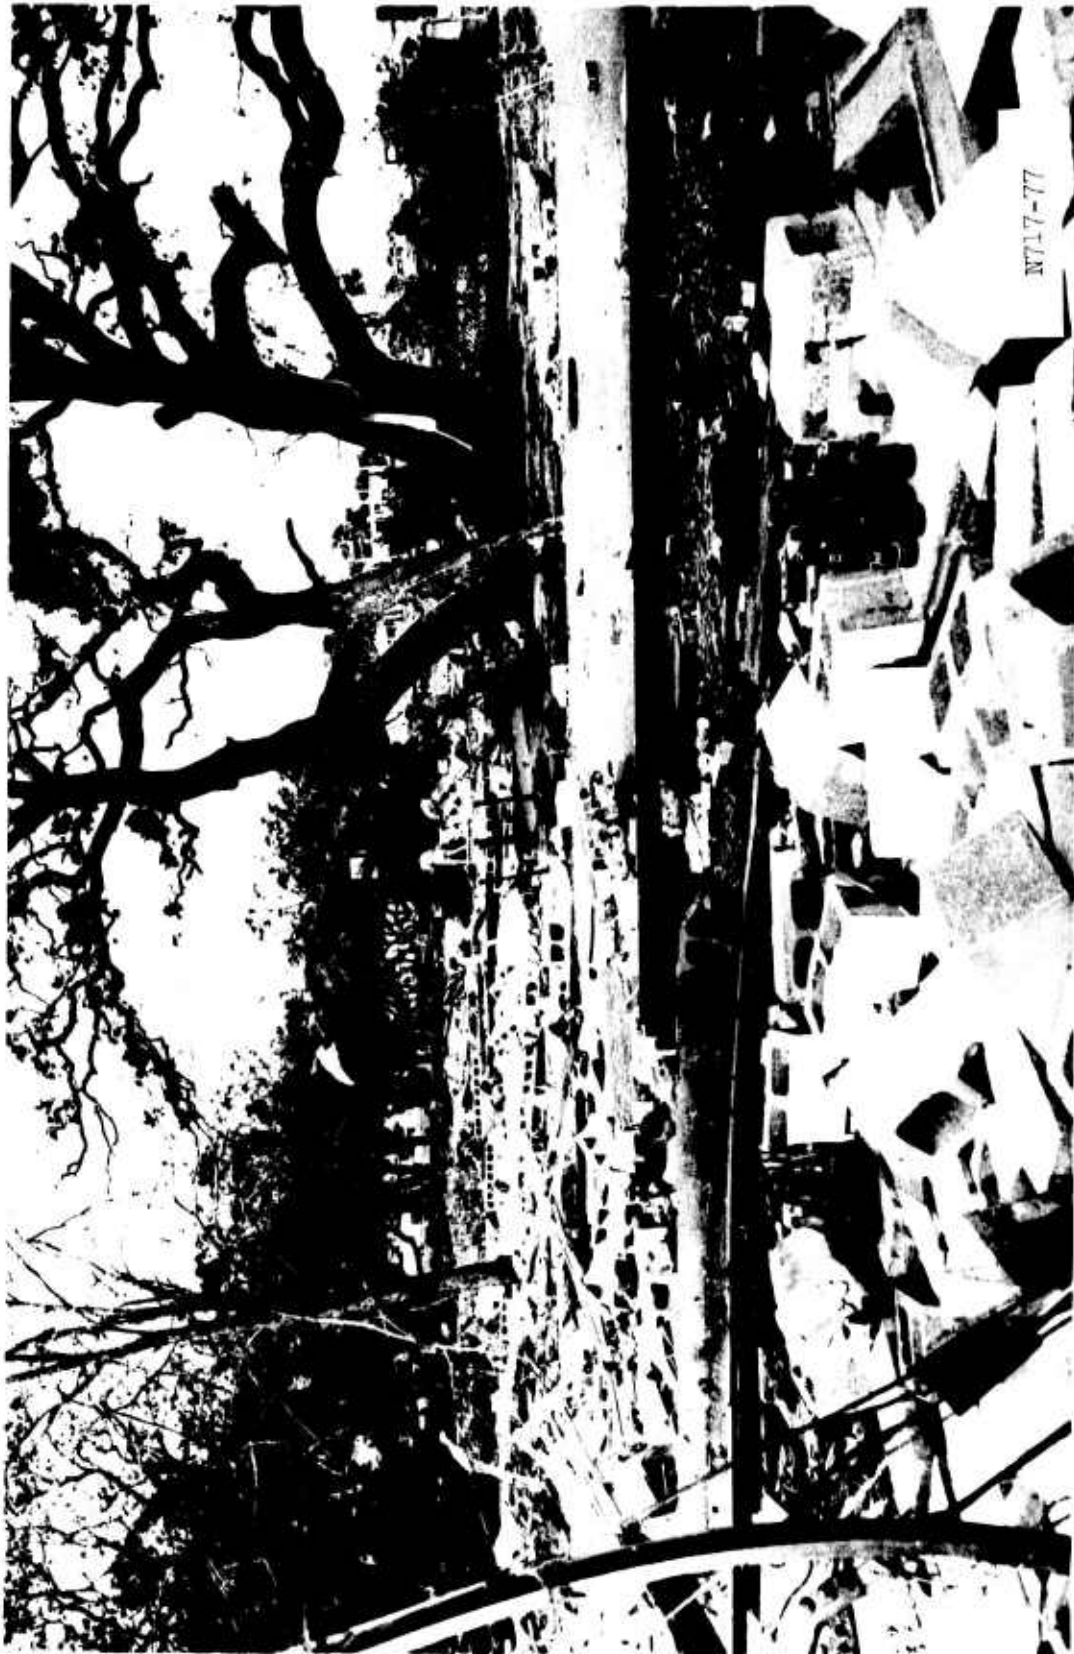
Figure 2.41 Motels, west of Biloxi, Mississippi.

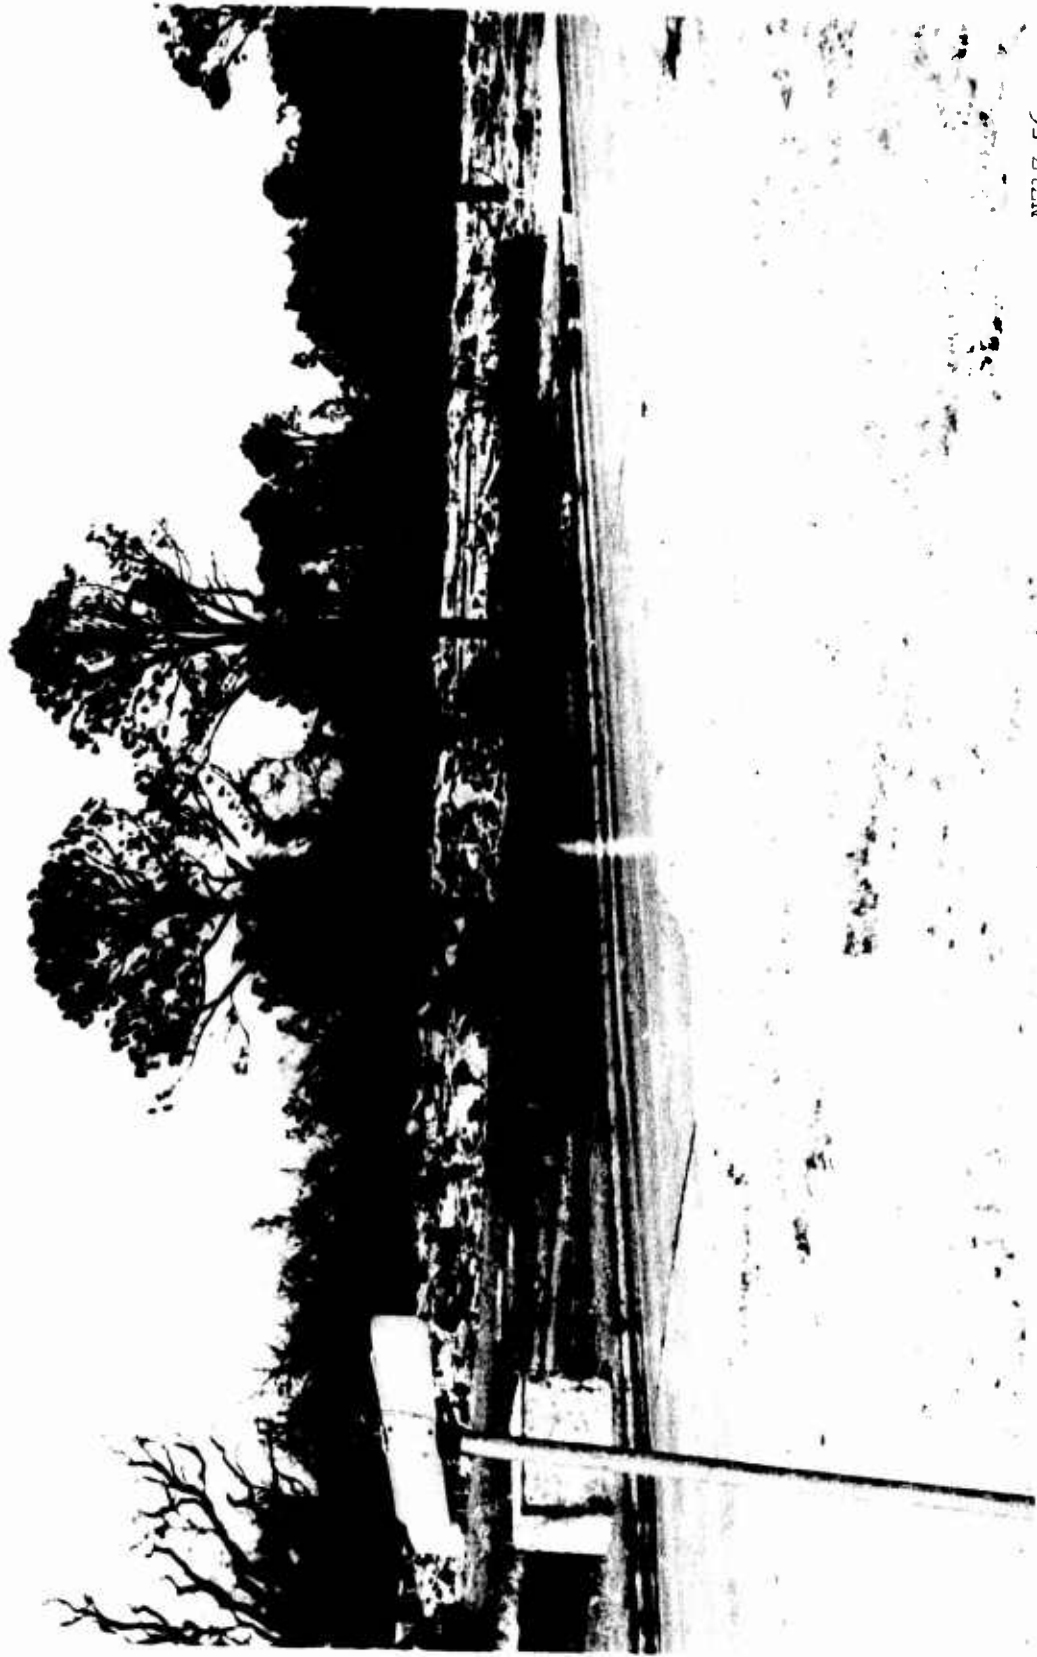
N717-56

Figure 2.43 shows the remains of the Richelieu Apartments, where 23 people died after ignoring repeated warnings by local authorities to vacate the building.

Figure 2.43 Richelieu Apartments (23 dead), Pass Christian, Mississippi.

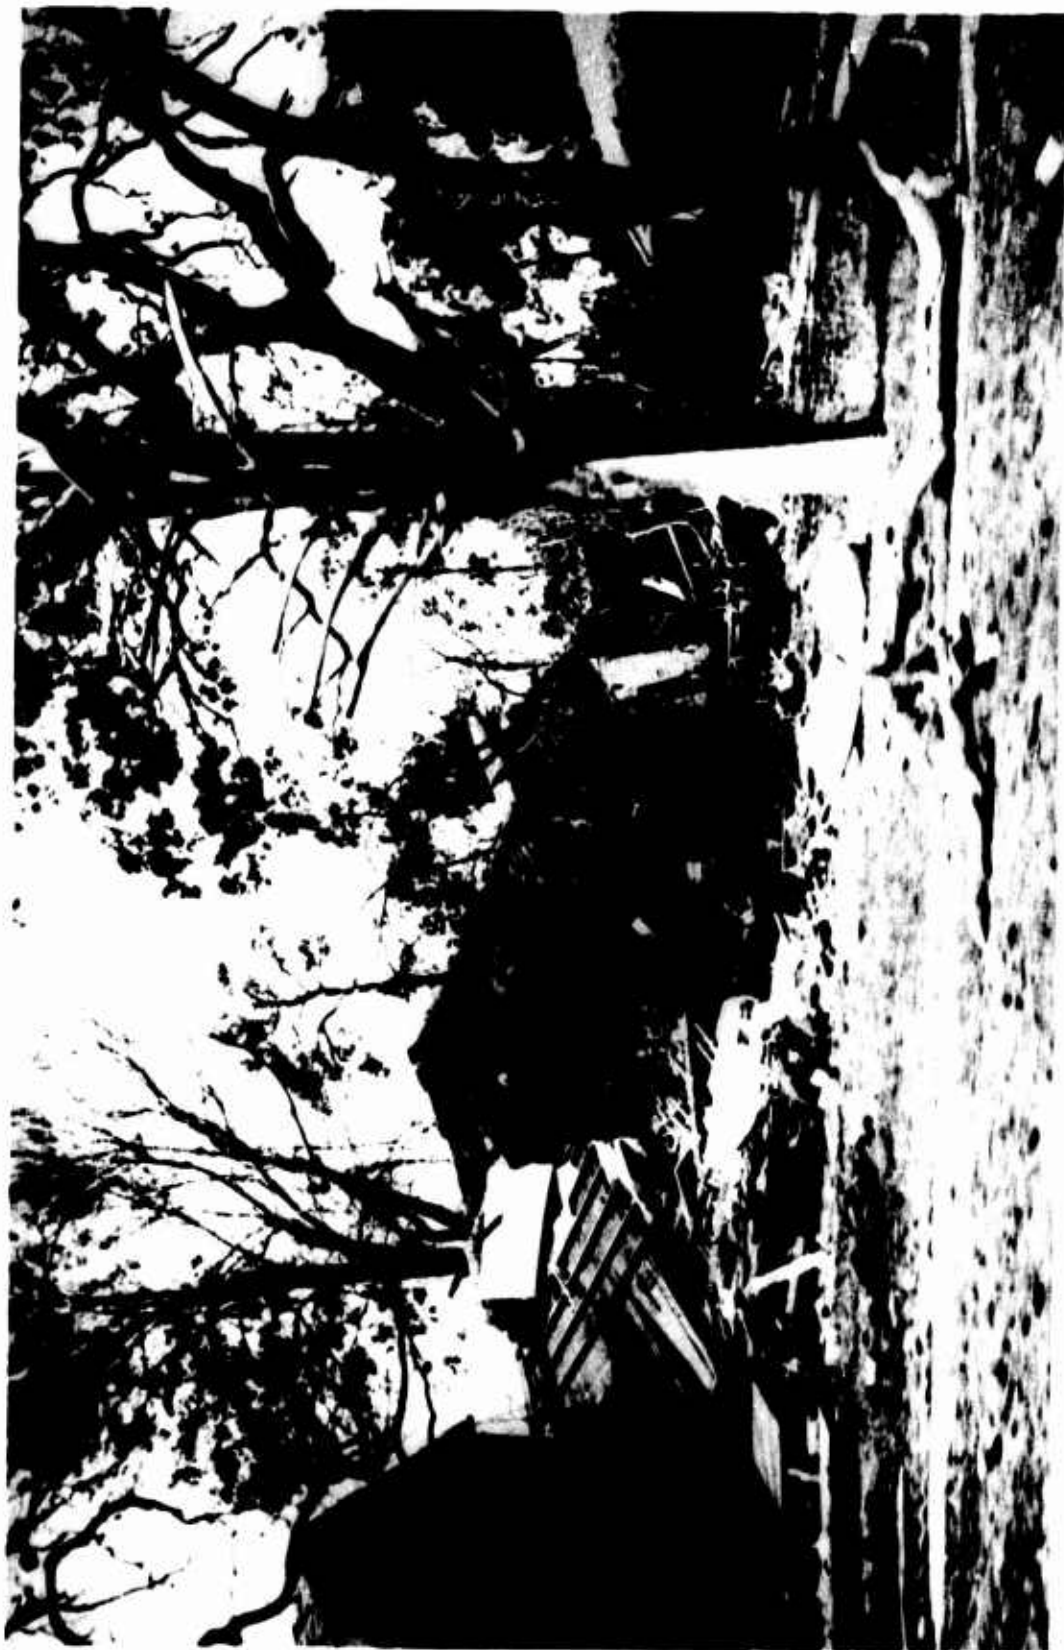
Figure 2.46 Service station, west Gulfport area.

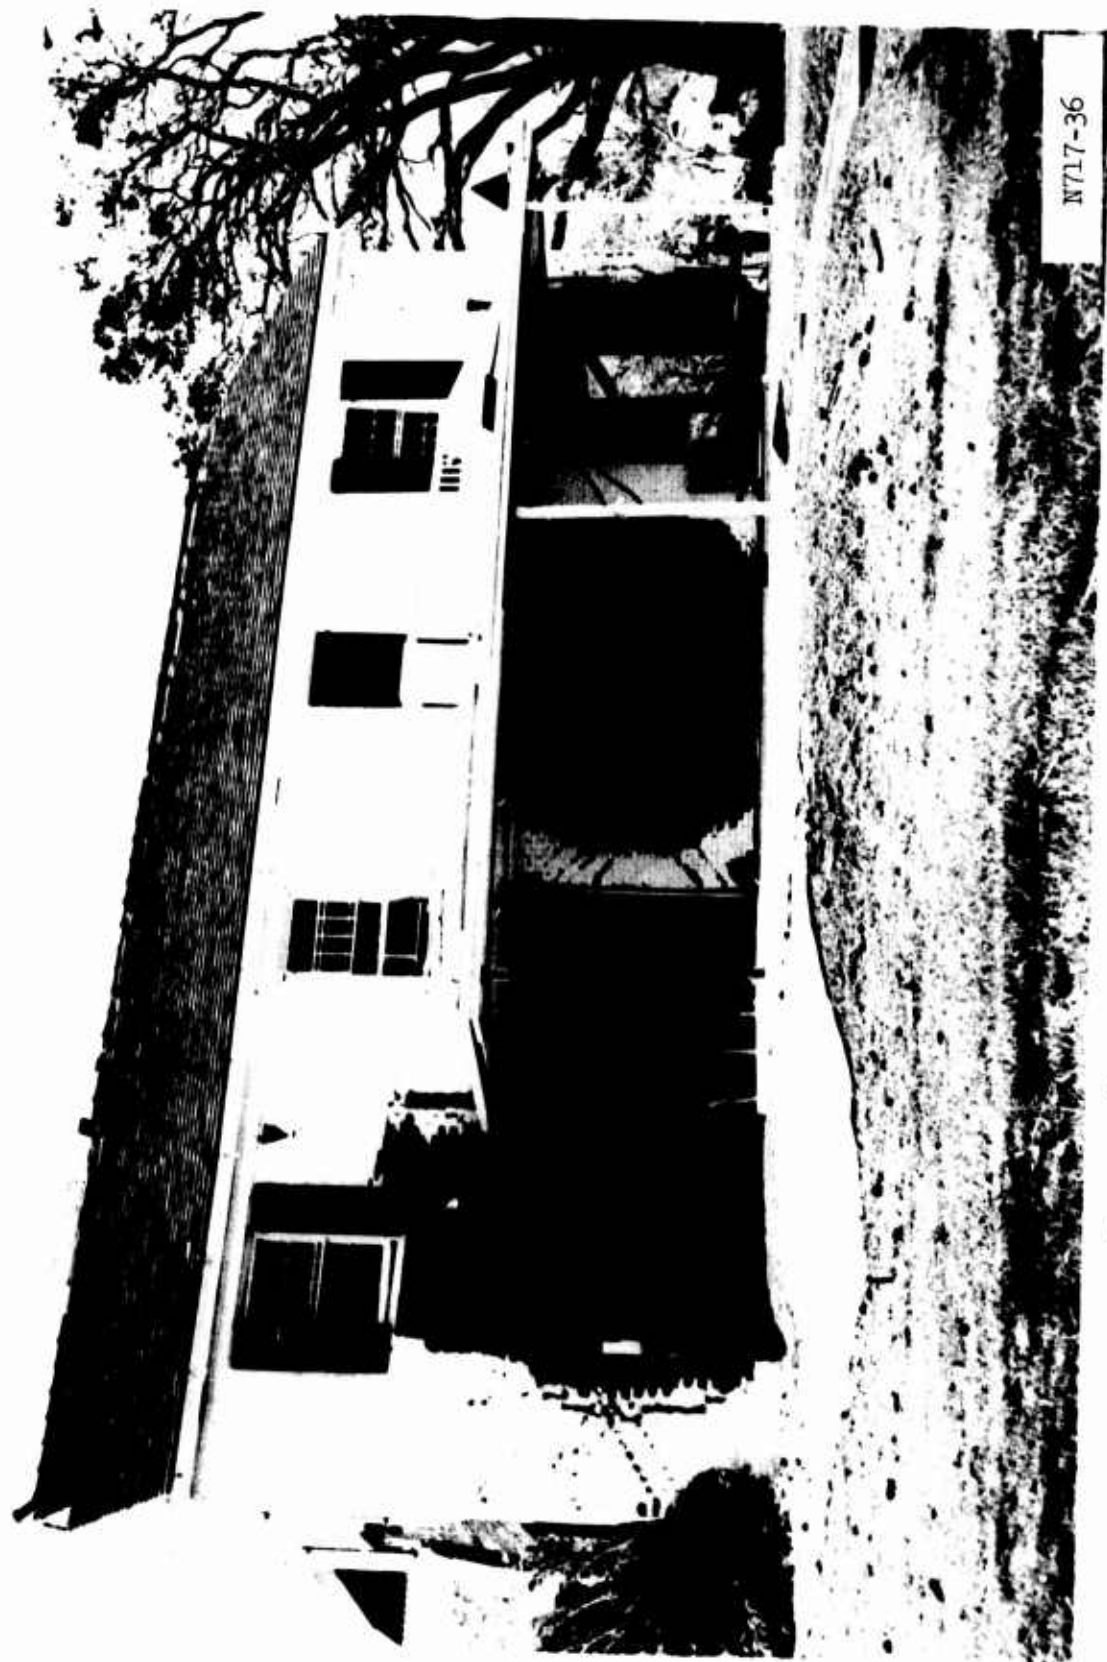
Figure 2.48 Collapsed frame house, Long Beach area.

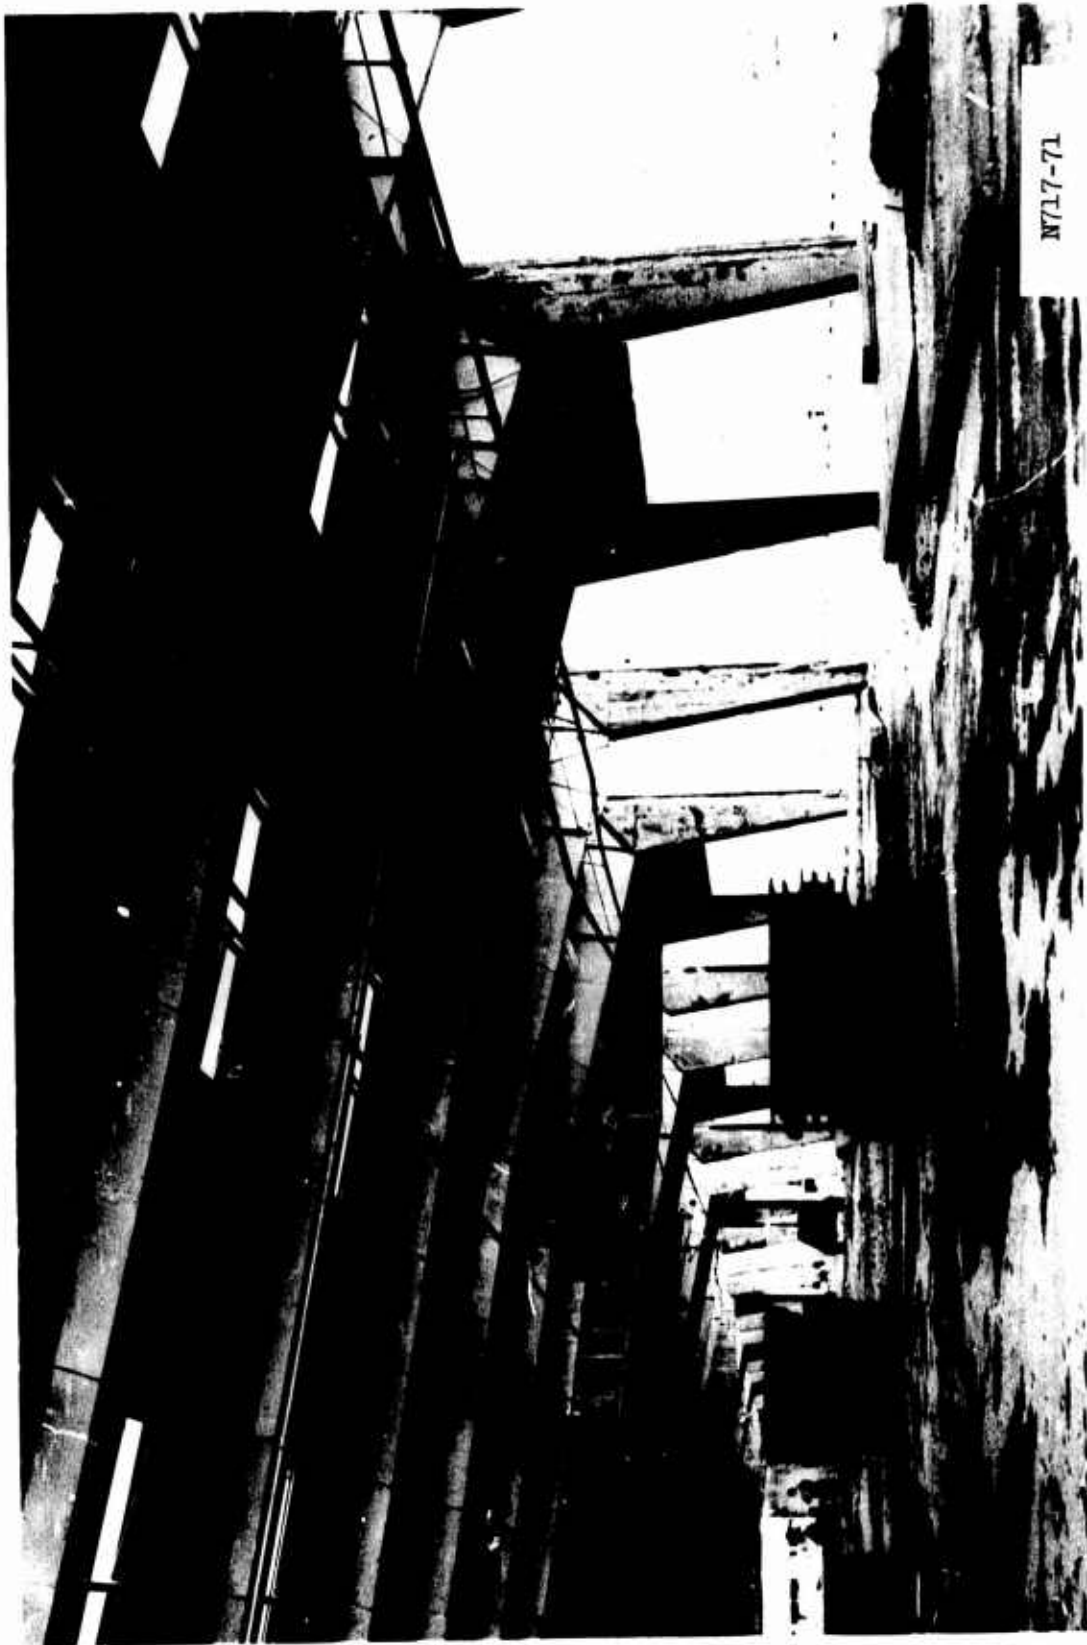
This building is a large clear span (span of about 125 feet) warehouse located at the southern tip of the Port of Gulfport. It is of rigid-frame construction with combination columns (steel sections encased in structural concrete) and with tilt-up concrete wall panels about 20 feet square by 6 inches thick and roll-up doors forming the walls. Light sheet metal purlins run along the length of the building and support a sheet metal roof. The columns appeared to have been cast in two steps, one to encase the steel section and the second to key in the tilt-up walls. The general construction is shown in Figures 3.1 and 3.2.

Figure 3.1 Close-up view of general construction of State Dock.

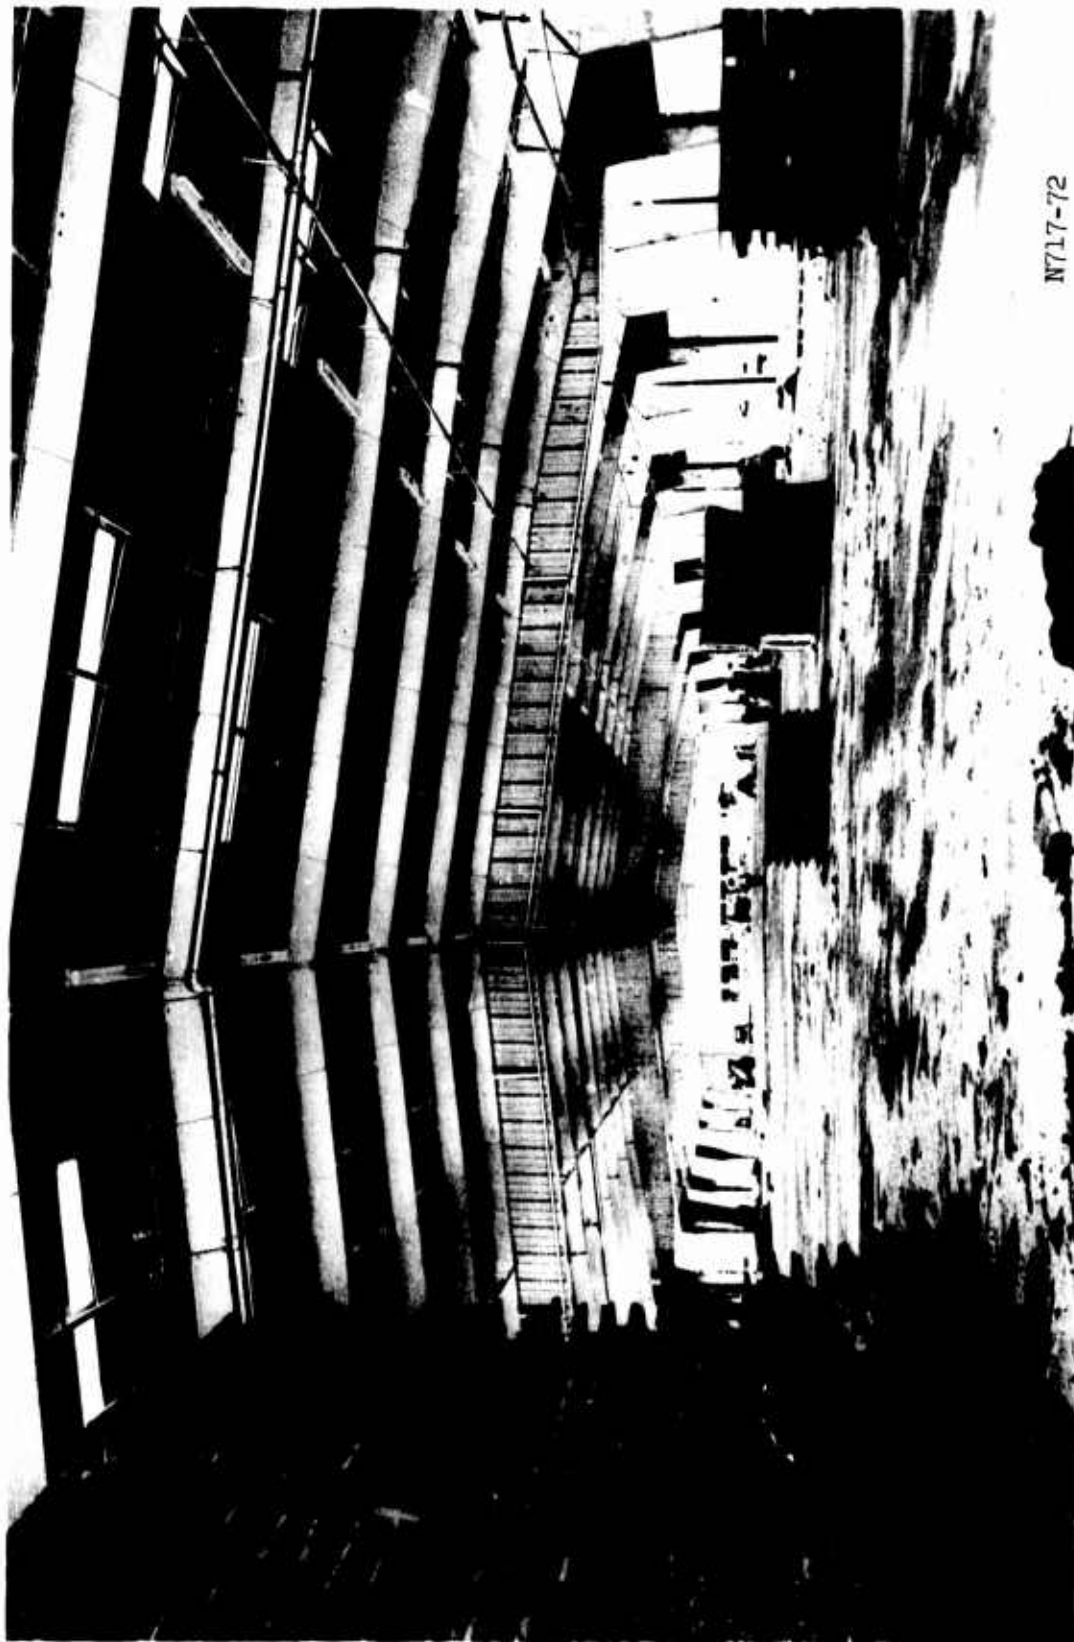
Figure 3.2 General view of State Dock.

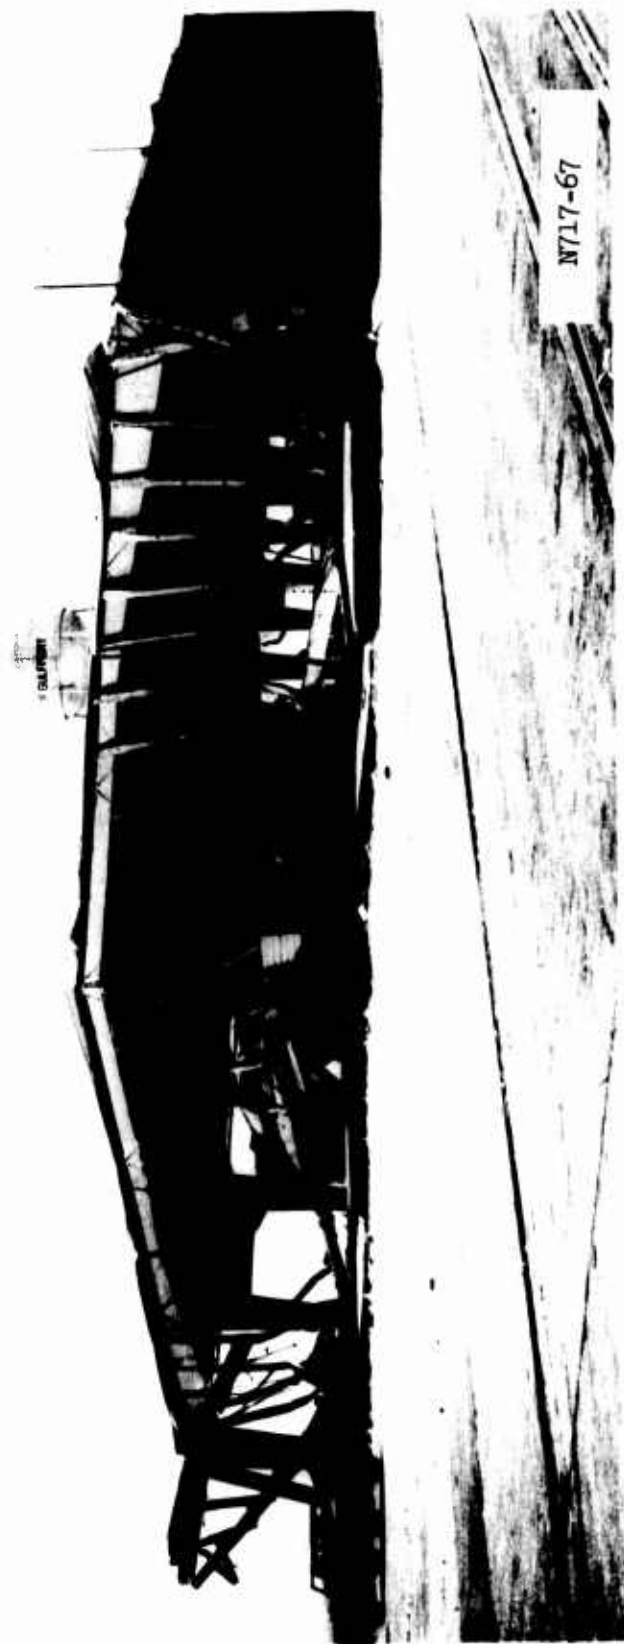
As shown in Figures 3.3 through 3.5, the end facing south-southeast and the first bent collapsed into the building with the tilt-up panels of this end wall falling with the columns. The tilt-up panels along the east side of the building were pushed into the structure, and those along the west side fell away from the structure. Like many other structures along the coast, this building was subjected to loadings far above those probably anticipated in their design.

Figure 3.3 Collapsed end wall of State Dock.

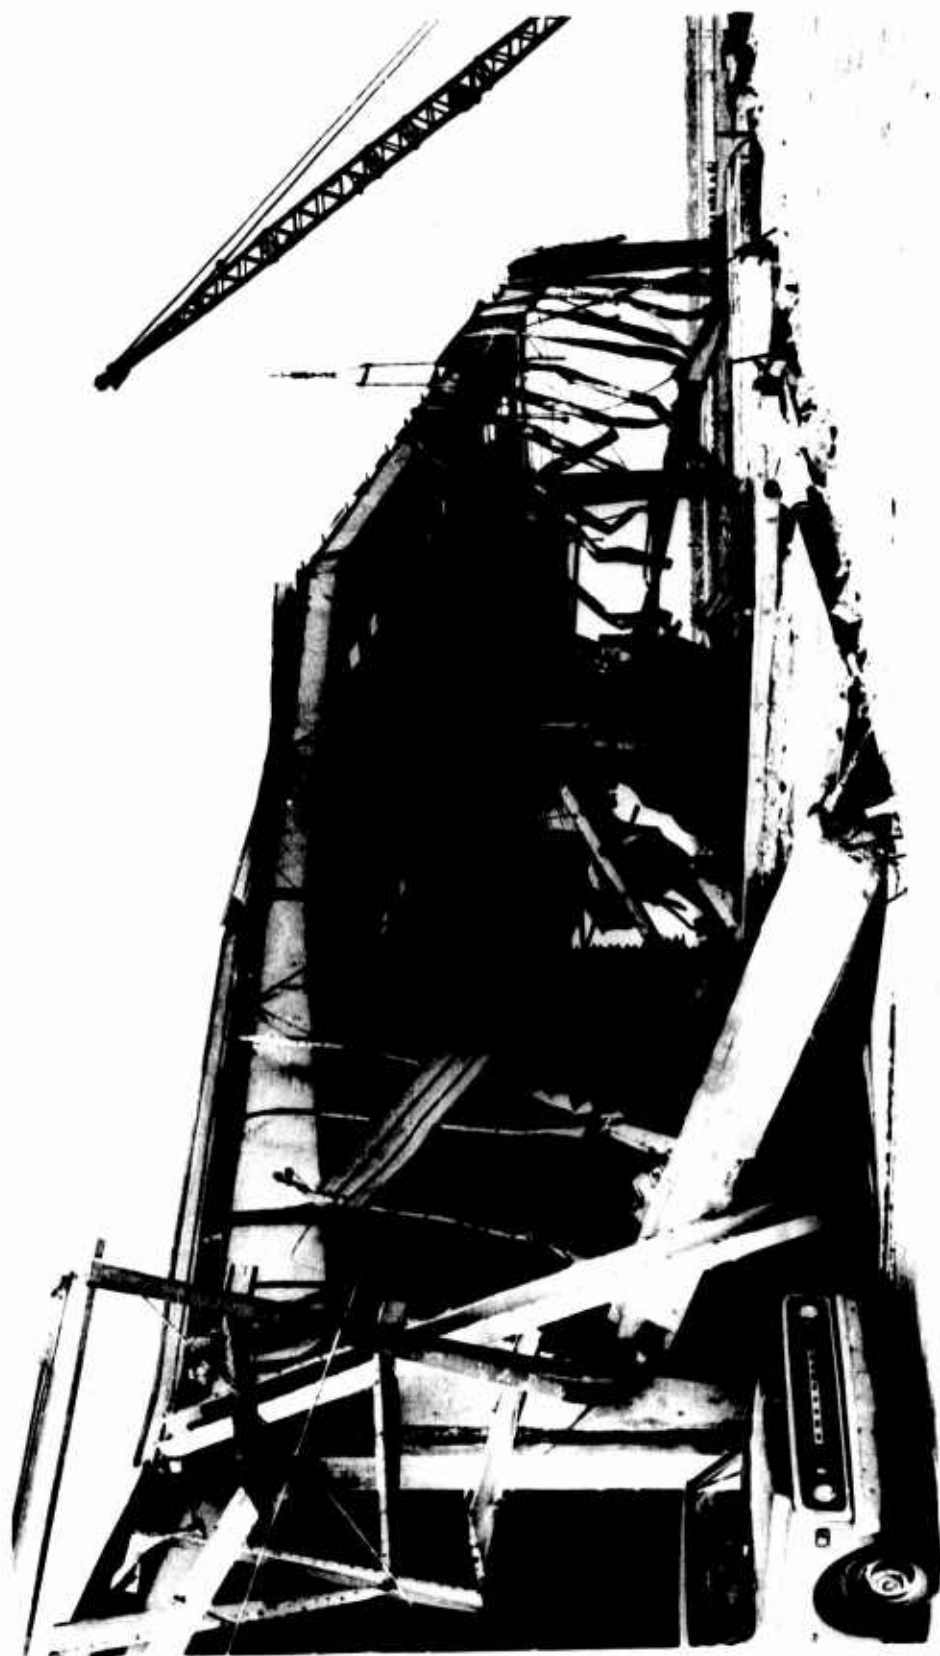
Figure 3.4 Close-up view of collapsed end wall of State Dock.

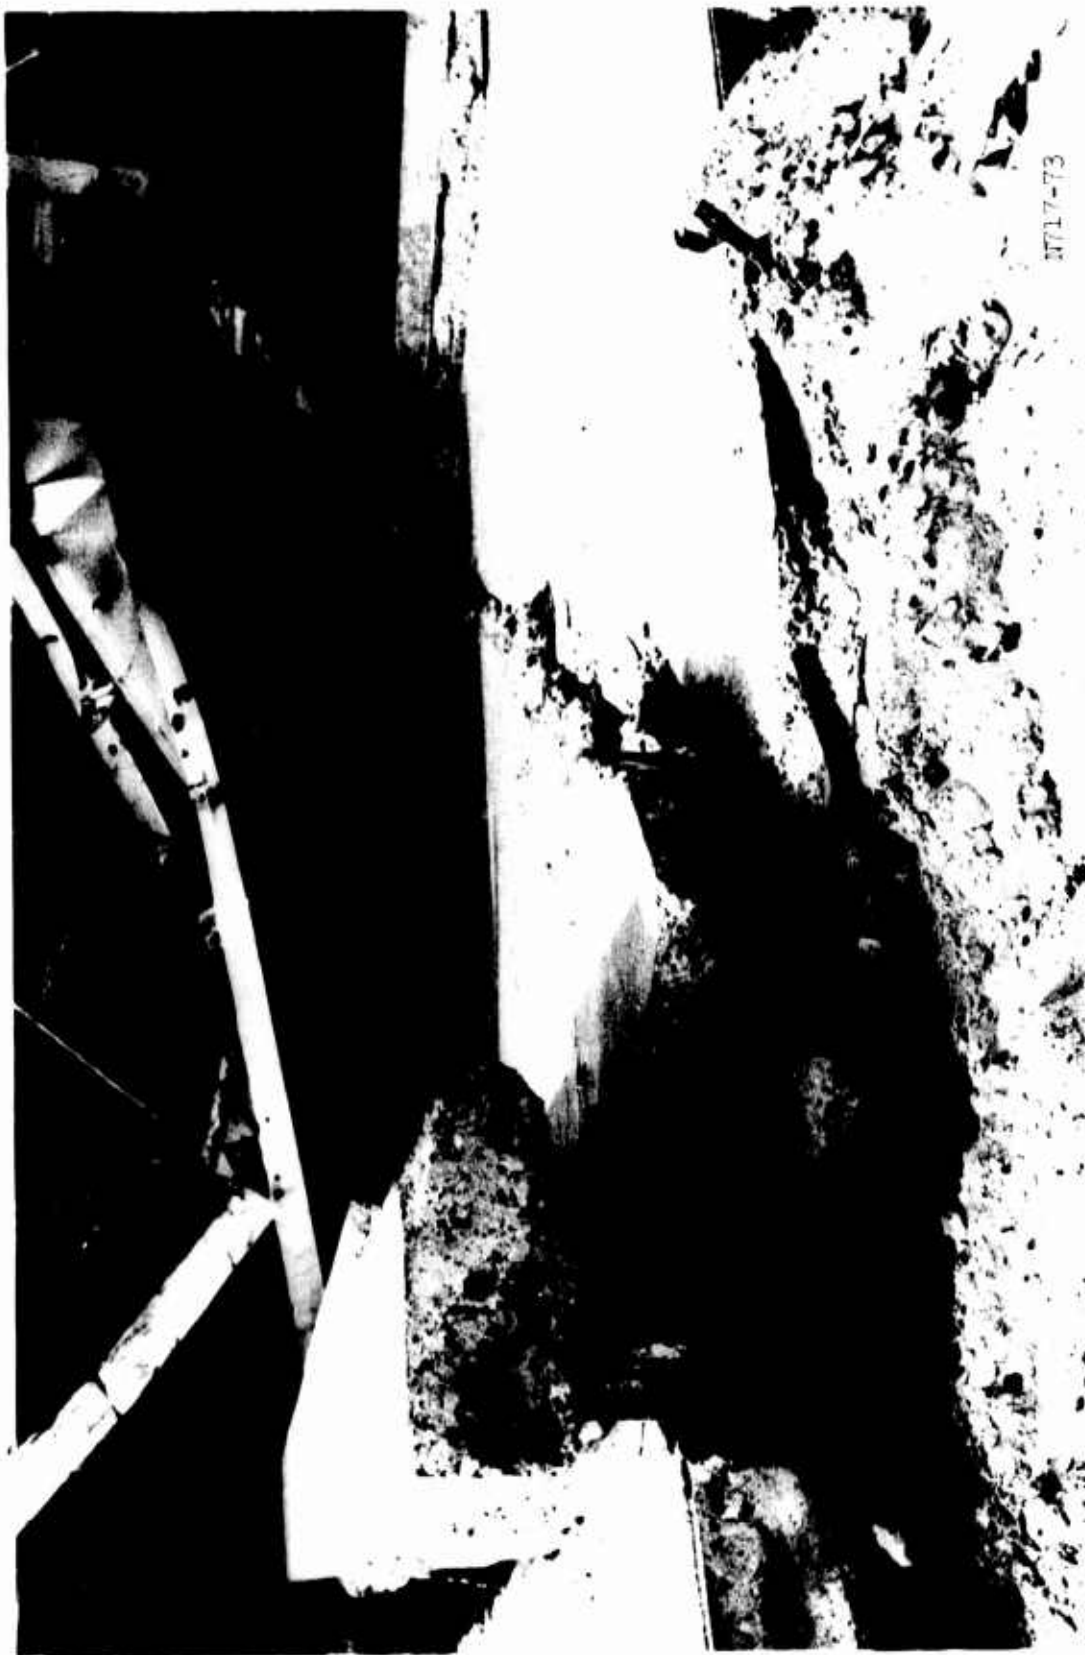
The connections at the base of the columns along the collapsed end wall failed. The dowels at the corner columns, shown in Figures 3.6 and 3.7, were very short, of small size, and had pulled out without breaking. The dowels in other columns along the end wall were larger and longer but still not adequate to develop the tensile strength of the dowel (Figure 3.8).

Figure 3.8 End-wall column and panel, State Dock.
